NBSIR 82-2553

Development of Interim Performance Criteria for Restoration Coatings for Porcelain Enamel Surfaces

June 1982

James F. Seiler
Paul G. Campbell

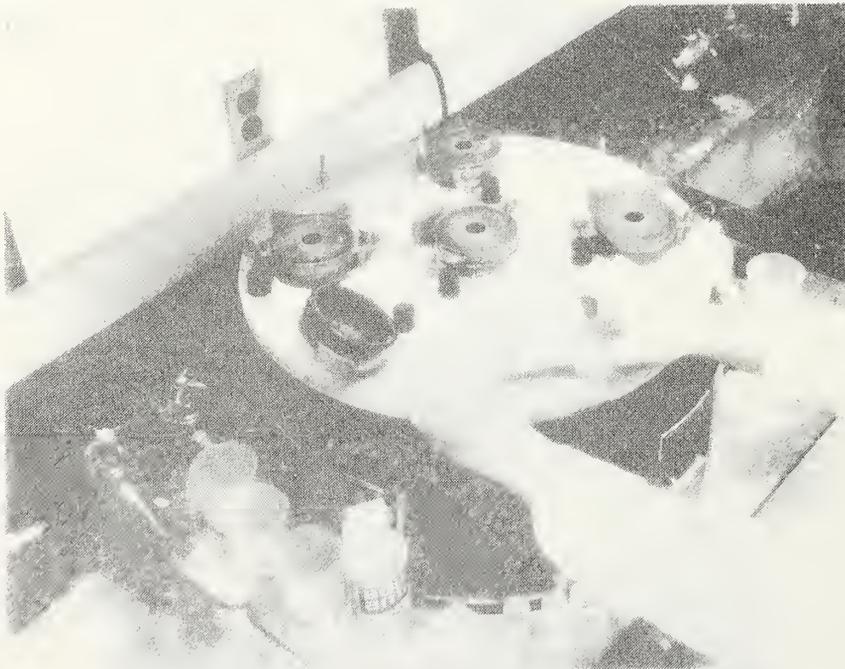
Figure 8. Modified abrasion procedure - placing test panels on apparatus

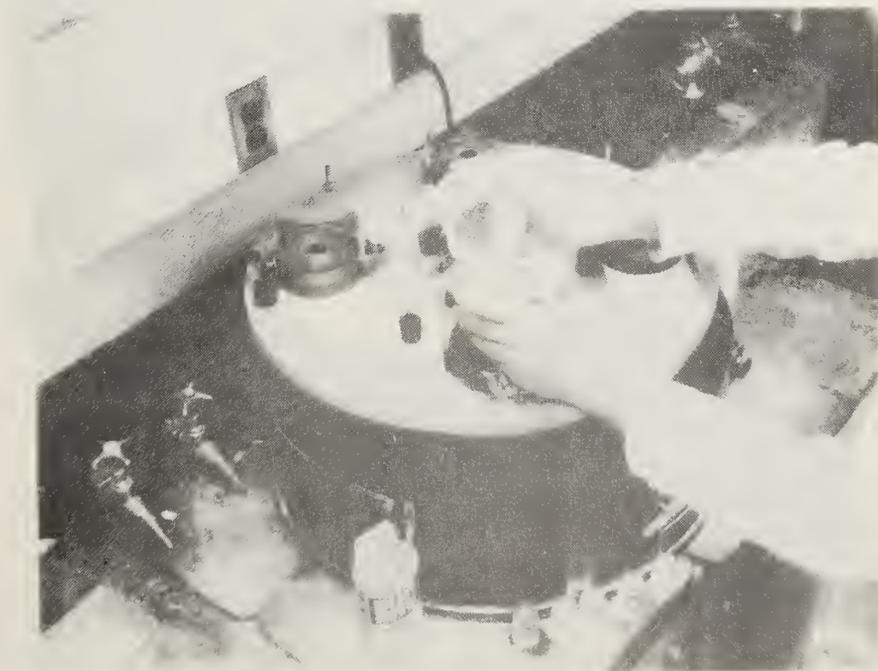
Figure 10. Modified abrasion procedure - addition of alloy balls

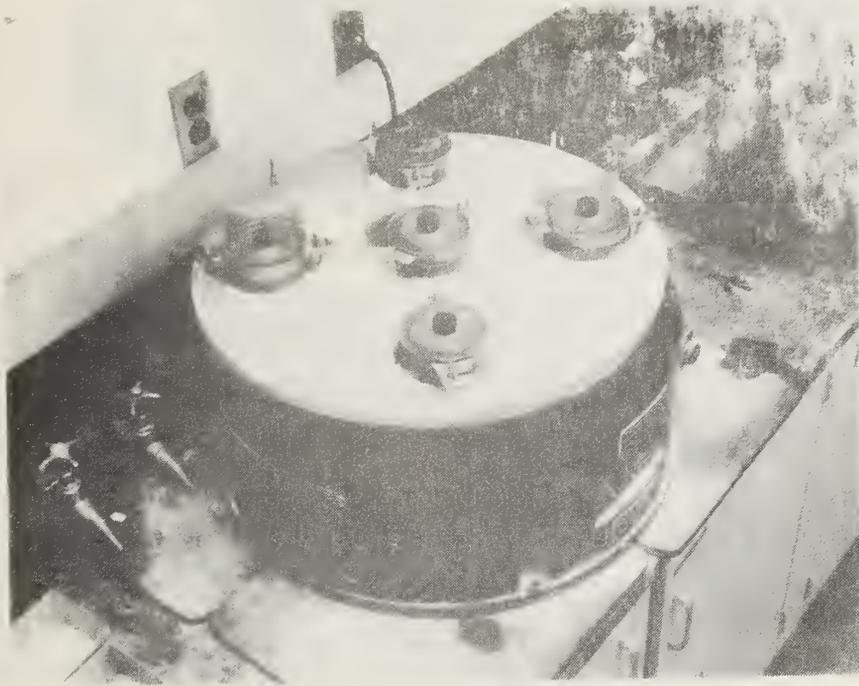
Figure 13. Modified abrasion procedure - abrasion test commences

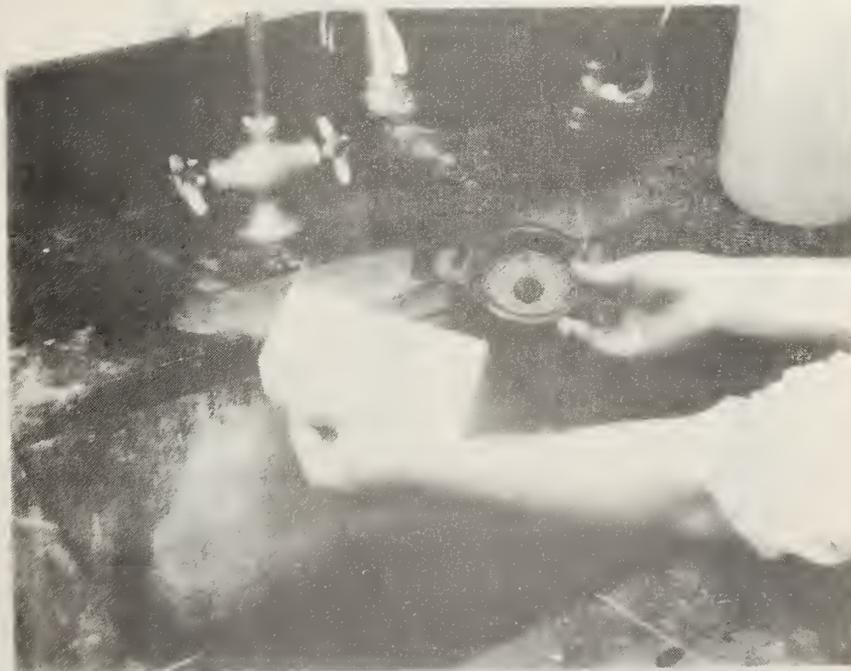
Figure 14. Modified abrasion procedure - removal of test panels and alloy balls after test

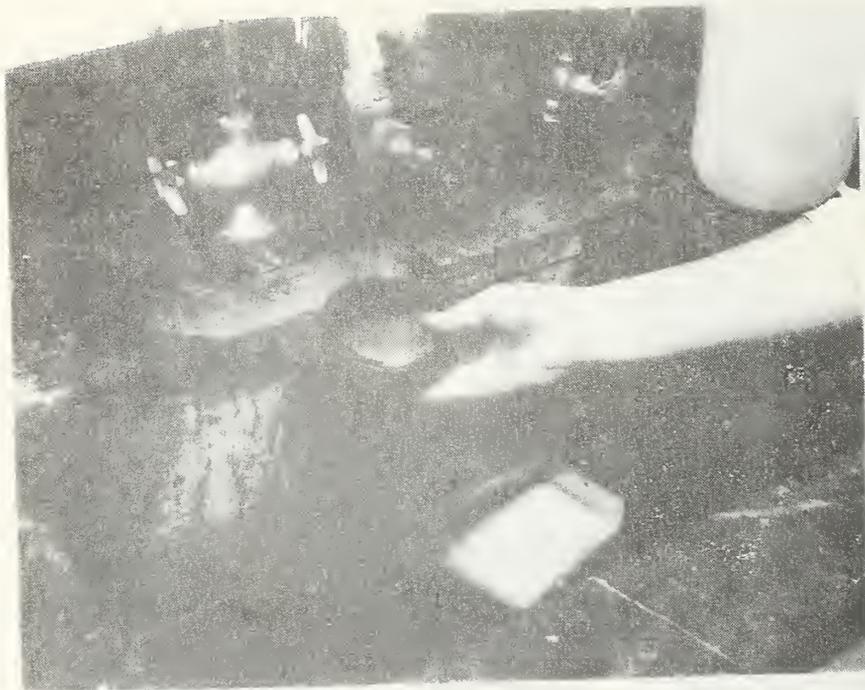
Figure 15. Modified abrasion procedure - rinsing alloy balls and test panels

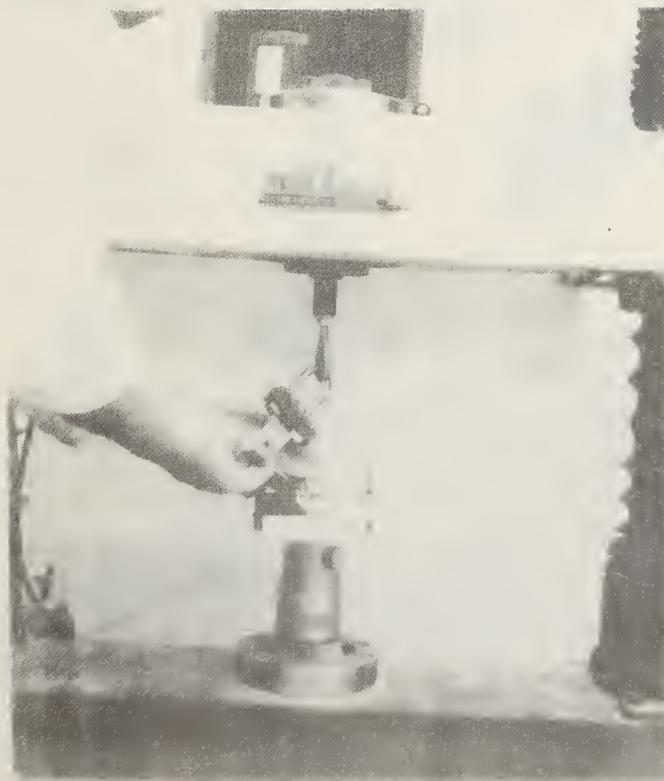
Figure 18. Adhesion procedure - joining upper and lower portions of yoke apparatus

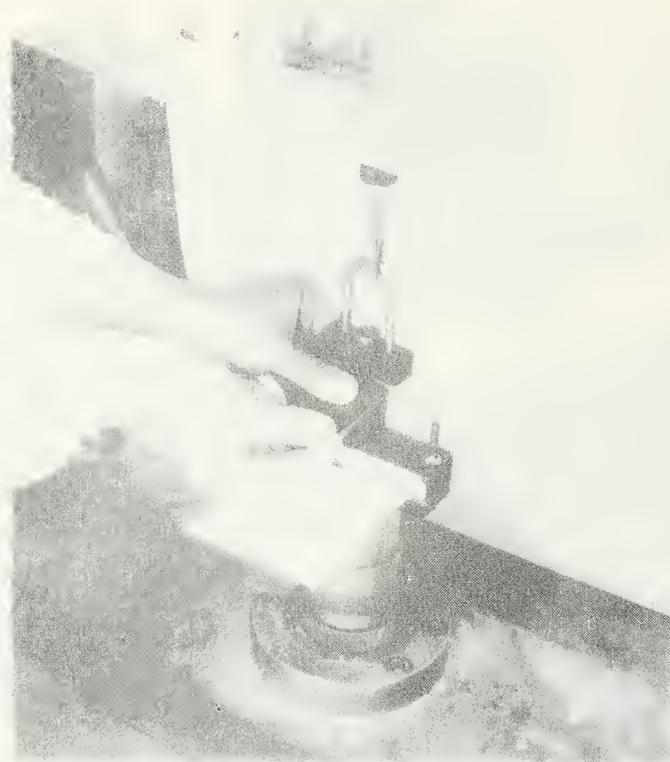
Figure 19. Adhesion procedure - joining upper and lower portions of yoke apparatus

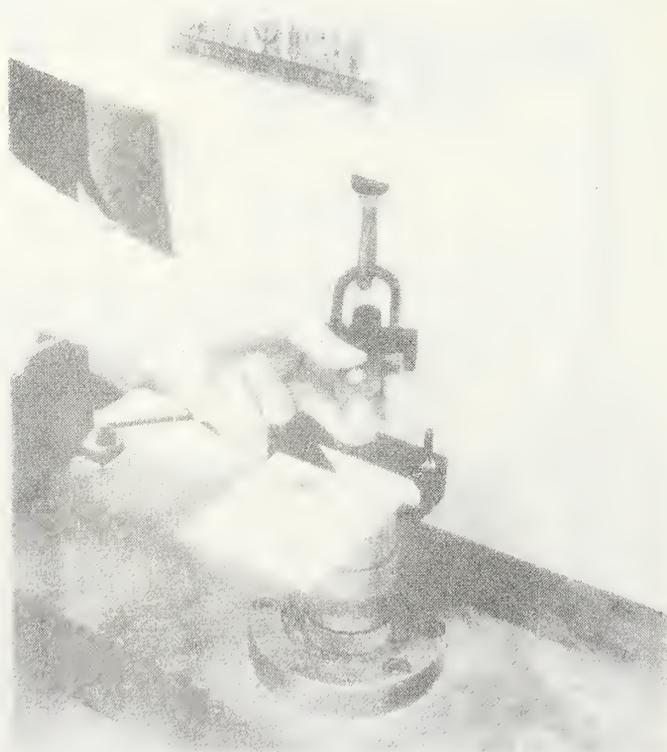
Figure 20. Adhesion procedure - after test, bottom of button showing delaminated coating

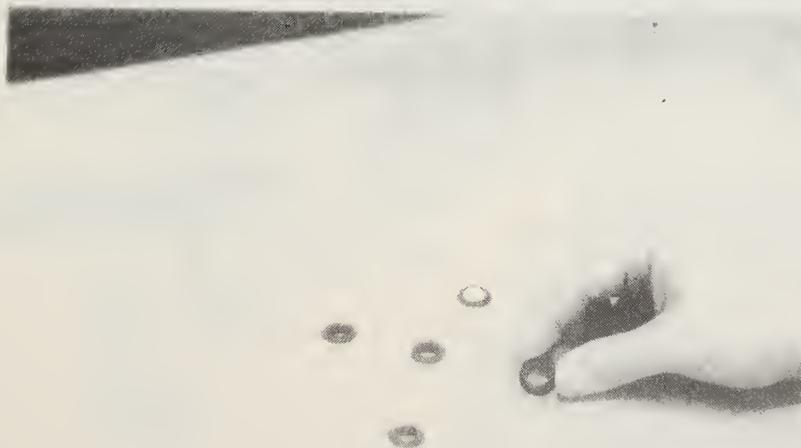
Figure 26. Stain resistance test procedure - chambers with rubber seals

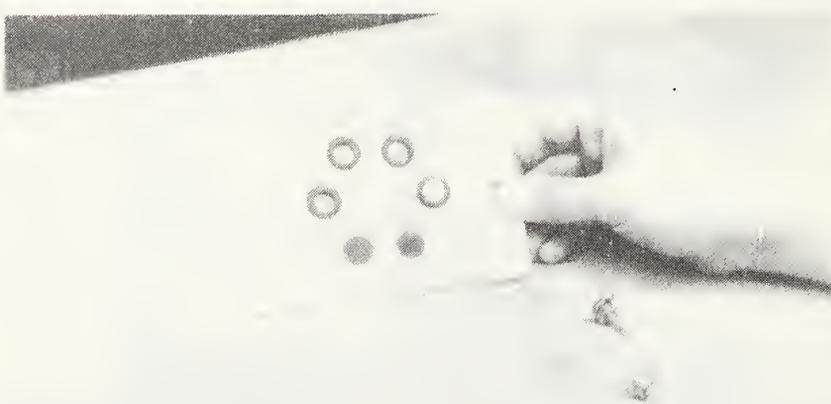
Figure 28. Stain resistance test procedure - upper holder prior to clamping

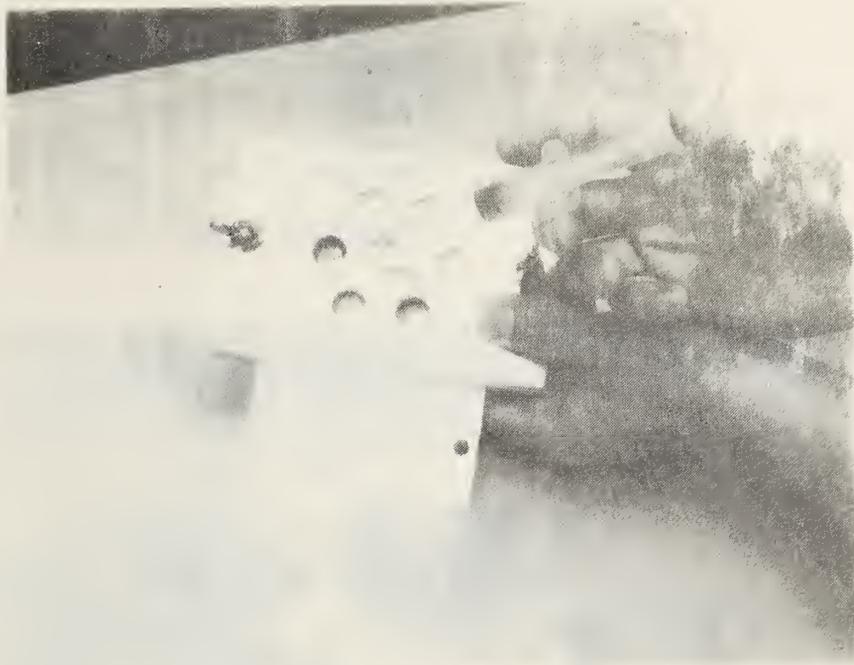
Figure 29. Stain resistance test procedure - application of liquid stain

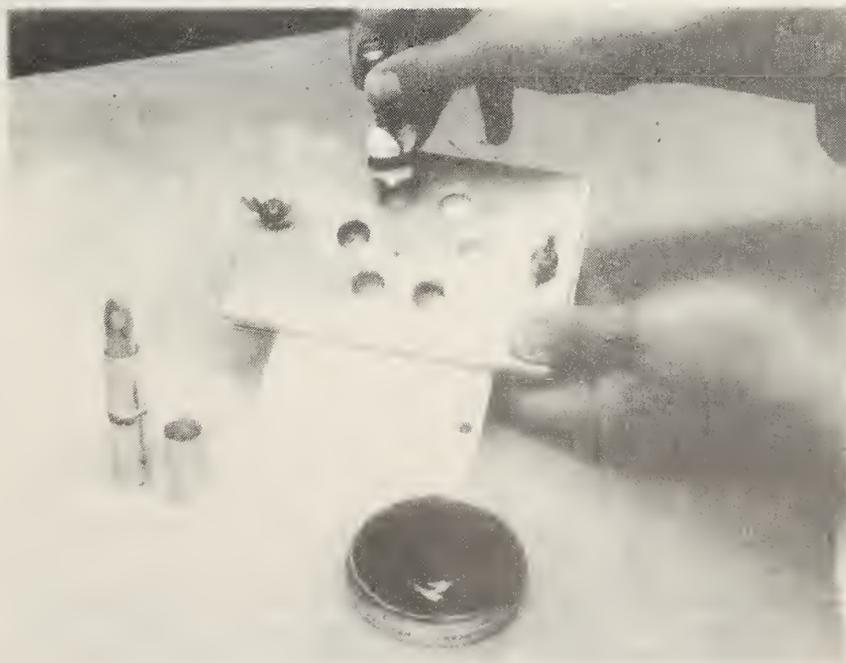
Figure 30. Stain resistance test procedure - application of solid stain

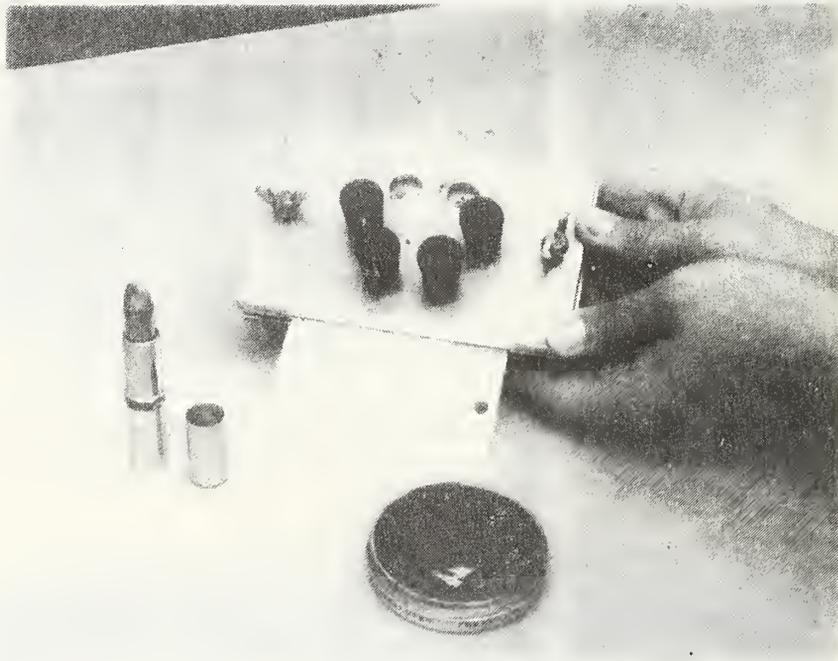
Figure 31. Stain resistance test procedure - test complete, removal of rubber seals
